# Access Compliance Report Public Rights-of-Way (Curb Ramps)

Main Street: N/A Cross Street: MAIN\_ST Location: NW

ADA ID: RPRK211102112657 Ramp Type: Type 4 - Parallel Initial Pass/Fail: Fail Overall Compliance: No Severity Score: 2

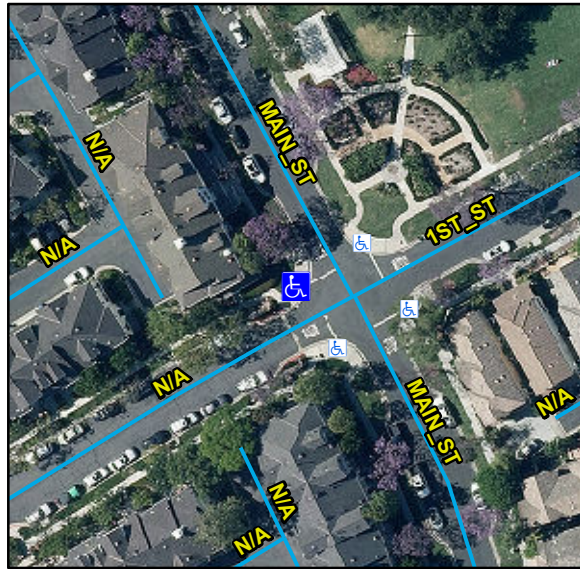
| Compliance | Description | Data | Compliance | Description | Data |
|---|---|---|---|---|---|
| No | Ramp Cross Slope LT (%) | 2.1 | Yes | Ramp Cross Slope RT (%) | 1 |

Remove & Replace Curb Ramp With Two New Directional Ramps or Equivalent.

R204.3, R304.5.3, STD 1115

\$ 4000
