# Access Compliance Report Public Rights-of-Way (Curb Ramps)

Main Street: 1ST\_ST Cross Street: MERCANTILE\_WAY Location: NW

ADA ID: RPRK211102112935 Ramp Type: Type 1 - Perpendicular Diagonal Initial Pass/Fail: Pass Overall Compliance: No Severity Score: 10

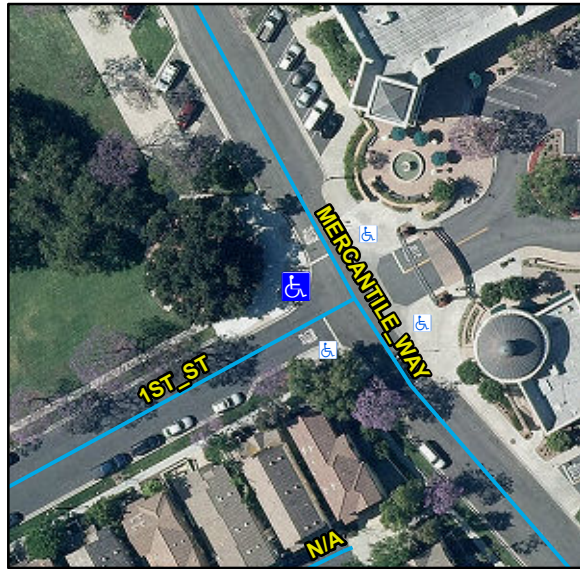
| Compliance | Description | Data | Compliance | Description | Data |
|---|---|---|---|---|---|
| Yes | Landing Cross Slope (%) | 1 | No | DWS Provided | No |

Install Detectable Warning System.
