# Access Compliance Report Public Rights-of-Way (Curb Ramps)

Main Street: **MERCANTILE\_WAY** Cross Street: **N/A** Location: **NE**

ADA ID: **RPRK211102113232** Ramp Type: **Type 1 - Perpendicular Diagonal** Initial Pass/Fail: **Fail** Overall Compliance: **No** Severity Score: **2**

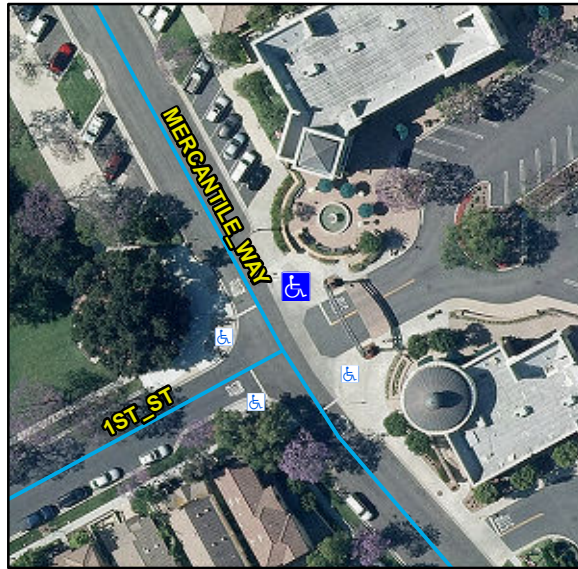
| Compliance | Description | Data | Compliance | Description | Data |
|---|---|---|---|---|---|
| <b>No</b> | Ramp Cross Slope (%) | <b>2.1</b> | <b>N/A</b> | Flare Traversable LT | <b>N/A</b> |

**Remove & Replace Curb Ramp With Two New Directional Ramps or Equivalent.**

**R304.2.2, R304.5.3, STD 1115**
