# Access Compliance Report Public Rights-of-Way (Curb Ramps)

Main Street: N/A Cross Street: MERCANTILE\_WAY Location: SE

ADA ID: RPRK211102113416 Ramp Type: Type 1 - Perpendicular Diagonal Initial Pass/Fail: Fail Overall Compliance: No Severity Score: 2

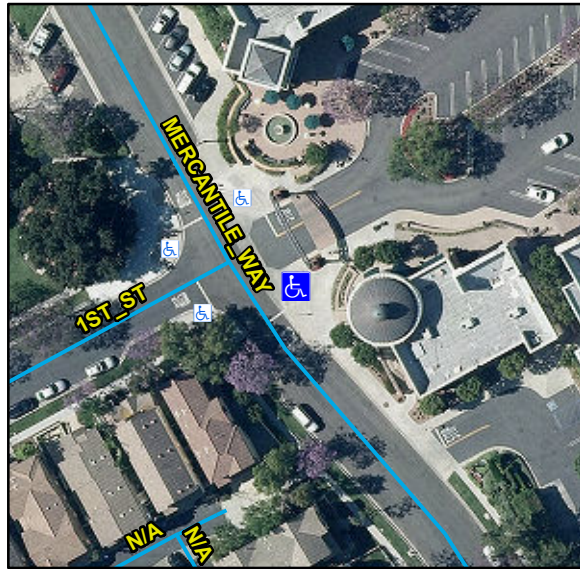
| Compliance | Description | Data | Compliance | Description | Data |
|---|---|---|---|---|---|
| No | Ramp Cross Slope (%) | 2.7 | N/A | Flare Traversable LT | N/A |

Remove & Replace Curb Ramp With Two New Directional Ramps or Equivalent.

R304.2.2, R304.5.3, STD 1115
