# Access Compliance Report Public Rights-of-Way (Curb Ramps)

Main Street: N/A Cross Street: MERCANTILE\_WAY Location: NW

ADA ID: RPRK211102113724 Ramp Type: Type 4 - Parallel Initial Pass/Fail: Fail Overall Compliance: No Severity Score: 30

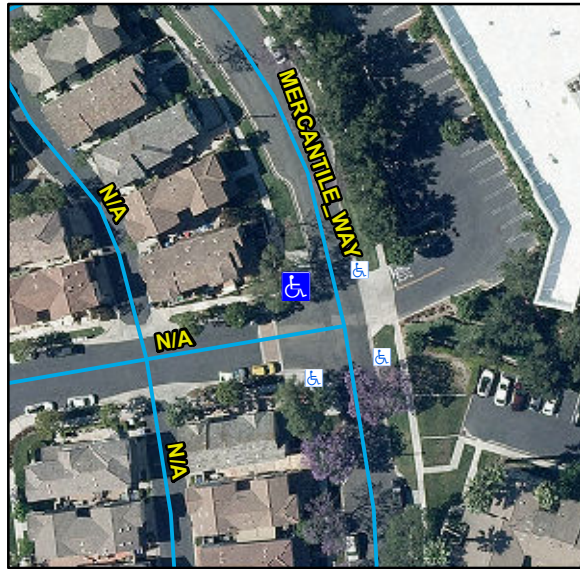
| Compliance | Description | Data | Compliance | Description | Data |
|---|---|---|---|---|---|
| Yes | Ramp Run Slope LT (%) | 0.8 | Yes | Ramp Run Slope RT (%) | 8.3 |
| Yes | Ramp Cross Slope LT (%) | 1.6 | No | Ramp Cross Slope RT (%) | 8 |

Remove & Replace Curb Ramp With Two New Directional Ramps or Equivalent.

R204.3, R304.5.3, STD 1115

Total Cost: \$ 4000
