# Access Compliance Report Public Rights-of-Way (Curb Ramps)

Main Street: **MERCANTILE\_WAY** Cross Street: **N/A** Location: **S**

ADA ID: **RPRK211102113902** Ramp Type: **Type 4 - Parallel** Initial Pass/Fail: **Fail** Overall Compliance: **No** Severity Score: **2**

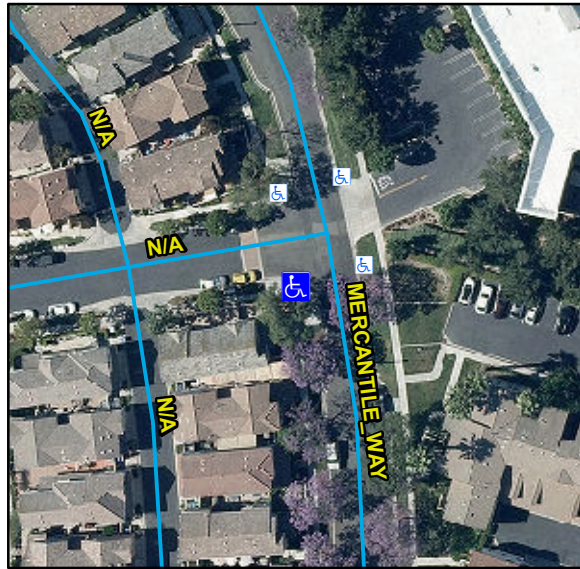
| Compliance | Description | Data | Compliance | Description | Data |
|---|---|---|---|---|---|
| <b>No</b> | Ramp Cross Slope LT (%) | <b>5</b> | <b>No</b> | Ramp Cross Slope RT (%) | <b>2.1</b> |
| <b>N/A</b> | Gutter Ponding | <b>N/A</b> | <b>No</b> | Curb Slope | <b>9.2</b> |
| <b>N/A</b> | Gutter Cross Slope (%) | <b>N/A</b> | <b>No</b> | Perpendicular Joint Present | <b>No</b> |

**Remove & Replace Curb Ramp With Two New Directional Ramps or Equivalent.**

**R304.2.2, R204.3, R304.5.3, STD 1115**
