# Access Compliance Report Public Rights-of-Way (Curb Ramps)

Main Street: CECIL\_PASTURE\_RD Cross Street: CECIL\_PASTURE\_RD Location: E

ADA ID: RPRK211102124258 Ramp Type: Type 4 - Parallel Initial Pass/Fail: Fail Overall Compliance: No Severity Score: 2

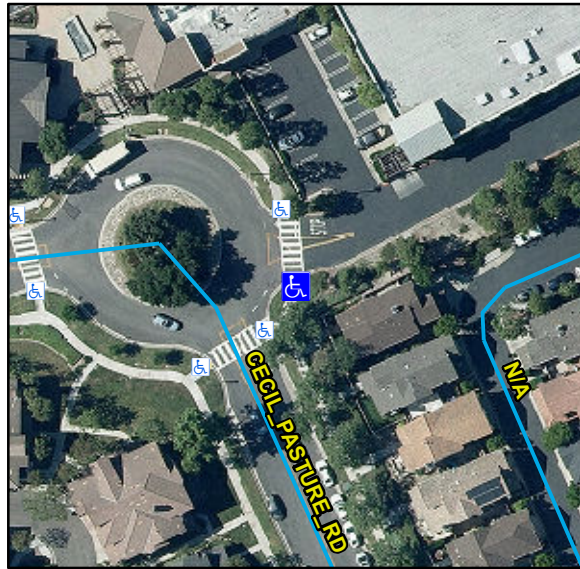
| Compliance | Description | Data | Compliance | Description | Data |
|---|---|---|---|---|---|
| N/A | Ramp Cross Slope LT (%) | -9999 | No | Ramp Cross Slope RT (%) | 2.3 |

Possible Solutions:

Remove & Replace Entire Ramp.
