# Access Compliance Report Public Rights-of-Way (Curb Ramps)

Main Street: CECIL\_PASTURE\_RD Cross Street: CECIL\_PASTURE\_RD Location: E

ADA ID: RPRK211102124457 Ramp Type: Type 4 - Parallel Initial Pass/Fail: Fail Overall Compliance: No Severity Score: 2

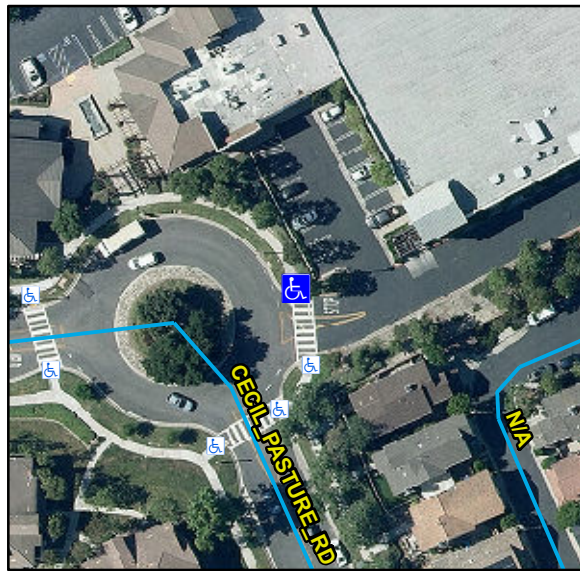
| Compliance | Description | Data | Compliance | Description | Data |
|---|---|---|---|---|---|
| No | Ramp Cross Slope LT (%) | 2.3 | N/A | Ramp Cross Slope RT (%) | -9999 |
| N/A | Gutter Ponding | N/A | No | Curb Slope | 15.6 |

Remove & Replace Entire Ramp.

R304.2.2, R304.5.3, STD 1115
