# Access Compliance Report Public Rights-of-Way (Curb Ramps)

Main Street: CECIL\_PASTURE\_RD Cross Street: CECIL\_PASTURE\_RD Location: W

ADA ID: RPRK211102124930 Ramp Type: Type 1 - Perpendicular Initial Pass/Fail: Pass Overall Compliance: No Severity Score: 5

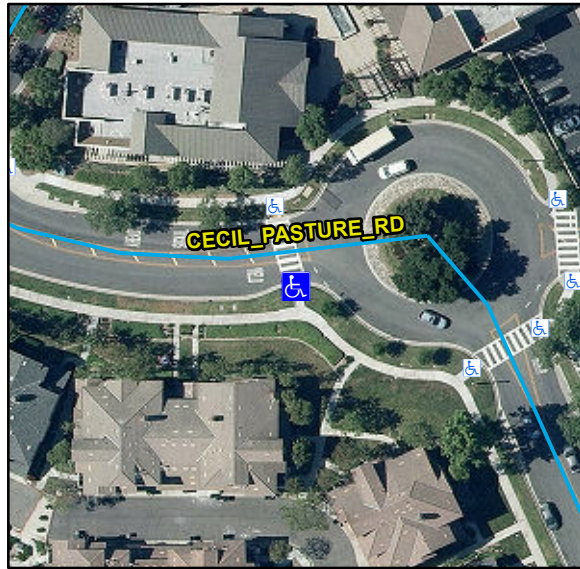
| Compliance | Description | Data | Compliance | Description | Data |
|---|---|---|---|---|---|
| No | Gutter Run Slope (%) | 9.8 | | Road Cross Slope (%) | N/A |
| No | Gutter Cross Slope (%) | 3.1 | | | |

Possible Solutions:

Remove & Replace Gutter.
