# Access Compliance Report Public Rights-of-Way (Curb Ramps)

Main Street: O\_NEILL\_DR Cross Street: DORRANCE\_DR Location: S

ADA ID: RPRK211102130707 Ramp Type: Type 4 - Parallel Initial Pass/Fail: Pass Overall Compliance: No Severity Score: 15

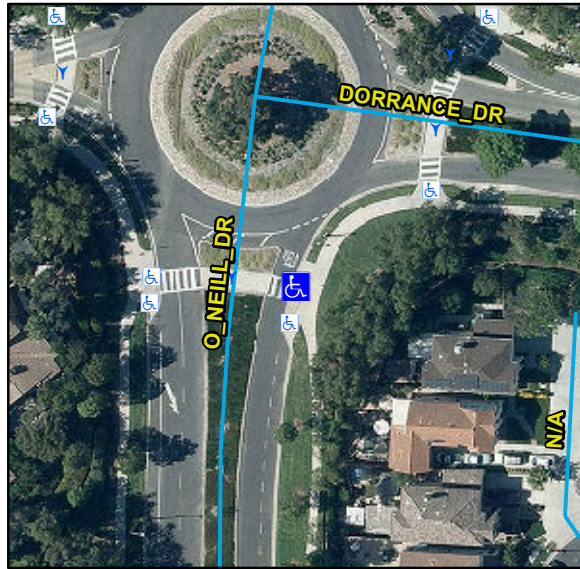
| Compliance | Description | Data | Compliance | Description | Data |
|---|---|---|---|---|---|
| N/A | Landing Present | Yes | No | DWS Provided | No |
| No | Gutter Run Slope (%) | 6.7 | | Road Cross Slope (%) | N/A |
| No | Gutter Cross Slope (%) | 4.6 | Yes | Perpendicular Joint Present | Yes |

Remove & Replace Entire Ramp. Remove & Replace Gutter.

R304.2.1, R305, R304.5.4, R304.5.3, STD 1115
