# Access Compliance Report Public Rights-of-Way (Curb Ramps)

Main Street: O\_NEILL\_DR Cross Street: DORRANCE\_DR Location: S

ADA ID: RPRK211102131525 Ramp Type: Type 4 - Parallel Initial Pass/Fail: Fail Overall Compliance: No Severity Score: 15

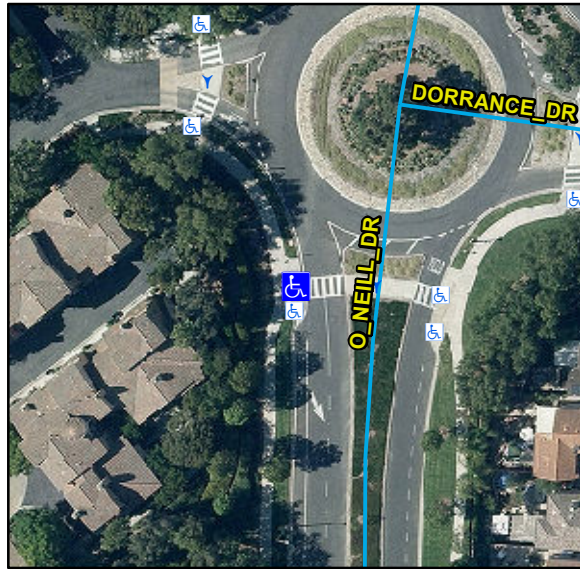
| Compliance | Description | Data | Compliance | Description | Data |
|---|---|---|---|---|---|
| N/A | Ramp Run Slope LT (%) | -9999 | No | Ramp Run Slope RT (%) | 9.7 |

Possible Solutions:

Remove & Replace Entire Ramp.
