# Access Compliance Report Public Rights-of-Way (Curb Ramps)

| Main Street: O_NEILL_DR | | Cross Street: O_NEILL_DR | | Location: | S |
| ADA ID: RPRK211102131658 | Ramp Type:Type 1 - Perpendicular | Initial Pass/Fail: Fail | Overall Compliance: No | Severity Score: | 30 |

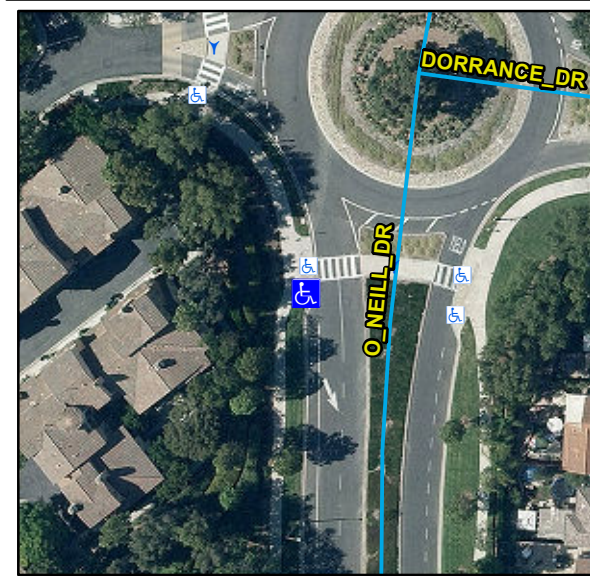
| Compliance | Description | Data | Compliance | Description | Data |
|---|---|---|---|---|---|
| No | Ramp Run Slope (%) | 12.1 | N/A | Flare Slope LT (%) | N/A |

Possible Solutions:

Remove & Replace Entire Ramp.

R204.3, R304.2.2, STD 1115
