# Access Compliance Report Public Rights-of-Way (Curb Ramps)

| Main Street: O_NEILL_DR | | Cross Street: DORRANCE_DR | | Location: | E |
| ADA ID: RPRK211102132807 | Ramp Type: Type 4 - Parallel | Initial Pass/Fail: Fail | Overall Compliance: No | Severity Score: | 2 |

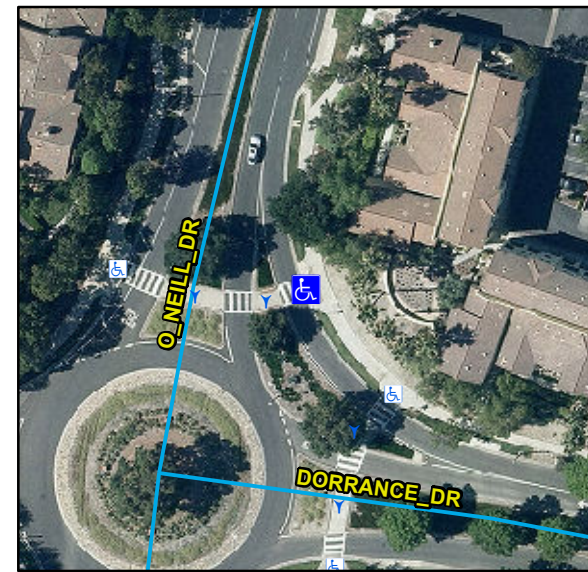
**R304.5.3, STD 1115**

| Compliance | Description | Data | Compliance | Description | Data |
|---|---|---|---|---|---|
| Yes | Ramp Cross Slope LT (%) | 0.4 | No | Ramp Cross Slope RT (%) | 2.7 |

**Remove & Replace Entire Ramp.**

Total Cost: \$ 2000
