# Access Compliance Report Public Rights-of-Way (Curb Ramps)

| Main Street: SKLAR_ST | | Cross Street: AVENDALE_BLVD | | Location: | SW |
| ADA ID: RPRK211102171554 | Ramp Type: Type 4 - Parallel | Initial Pass/Fail: Fail | Overall Compliance: No | Severity Score: | 15 |

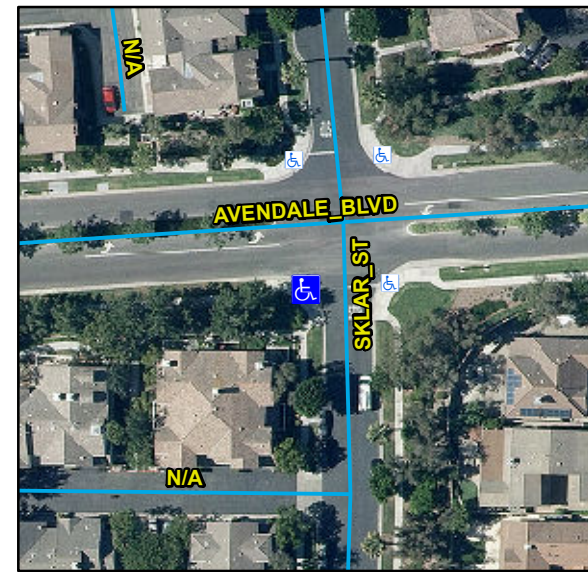
| Compliance | Description | Data | Compliance | Description | Data |
|---|---|---|---|---|---|
| No | Ramp Run Slope LT (%) | 9.9 | Yes | Ramp Run Slope RT (%) | 1.9 |

**Remove & Replace Curb Ramp With Two New Directional Ramps or Equivalent.**

**R304.3.2, STD 1115**

Total Cost: \$ 4000

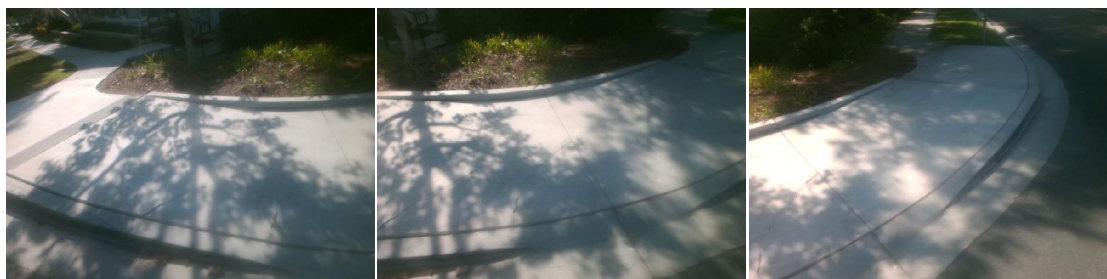
| Compliance | Description | Data | Compliance | Description | Data |
|---|---|---|---|---|---|
| N/A | Ramp Length LT (in) | 134 | N/A | Ramp Length RT (in) | 134 |
| Yes | Ramp Width LT (in) | 87 | Yes | Ramp Width RT (in) | 87 |
| Yes | Ramp Cross Slope LT (%) | 0.2 | Yes | Ramp Cross Slope RT (%) | 1.2 |
