# Access Compliance Report Public Rights-of-Way (Curb Ramps)

Main Street: AVENDALE\_BLV D Cross Street: SKLAR\_ST Location: SE

ADA ID: RPRK211102172408 Ramp Type: Type 4 - Parallel Initial Pass/Fail: Fail Overall Compliance: No Severity Score: 45

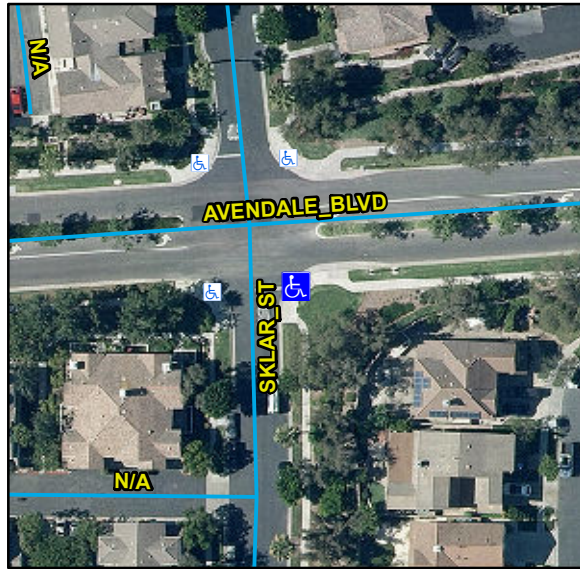
| Compliance | Description | Data | Compliance | Description | Data |
|---|---|---|---|---|---|
| No | Ramp Run Slope LT (%) | 19.9 | Yes | Ramp Run Slope RT (%) | 1.6 |
| Yes | Ramp Cross Slope LT (%) | 1.8 | No | Ramp Cross Slope RT (%) | 5.3 |

**Remove & Replace Curb Ramp With Two New Directional Ramps or Equivalent.**

**R204.3, R304.3.2, R304.5.3, STD 1115**
