# Access Compliance Report Public Rights-of-Way (Curb Ramps)

Main Street: SKLAR\_ST Cross Street: AVENDALE\_BLVD Location: NE

ADA ID: RPRK211102172930 Ramp Type: Type 4 - Parallel Initial Pass/Fail: Fail Overall Compliance: No Severity Score: 32

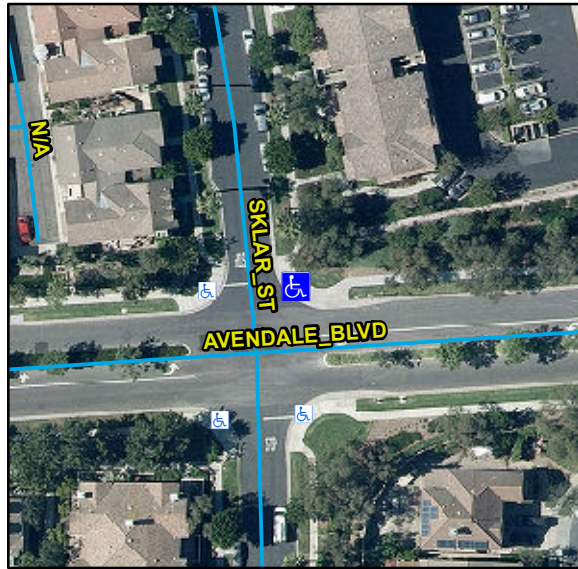
| Compliance | Description | Data | Compliance | Description | Data |
|---|---|---|---|---|---|
| Yes | Ramp Run Slope LT (%) | 3.8 | No | Ramp Run Slope RT (%) | 18.5 |
| No | Ramp Cross Slope LT (%) | 3 | Yes | Ramp Cross Slope RT (%) | 0.6 |

Remove & Replace Curb Ramp With Two New Directional Ramps or Equivalent.
