# Access Compliance Report Public Rights-of-Way (Curb Ramps)

Main Street: AVENDALE\_BLV D Cross Street: SKLAR\_ST Location: NW

ADA ID: RPRK211103122931 Ramp Type: Type 4 - Parallel Initial Pass/Fail: Fail Overall Compliance: No Severity Score: 15

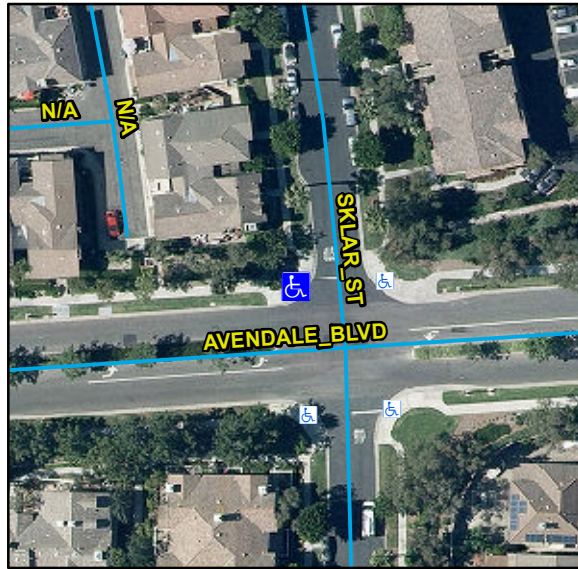
| Compliance | Description | Data | Compliance | Description | Data |
|---|---|---|---|---|---|
| Yes | Ramp Run Slope LT (%) | 1 | No | Ramp Run Slope RT (%) | 10.8 |

Remove & Replace Curb Ramp With Two New Directional Ramps or Equivalent.

R204.3, R304.3.2, STD 1115
