# Access Compliance Report Public Rights-of-Way (Curb Ramps)

| Main Street: N/A | Cross Street: SKLAR_ST | Location: N |

| ADA ID: RPRK211103124328 | Ramp Type: Type 4 - Parallel | Initial Pass/Fail: Fail | Overall Compliance: No | Severity Score: 2 |

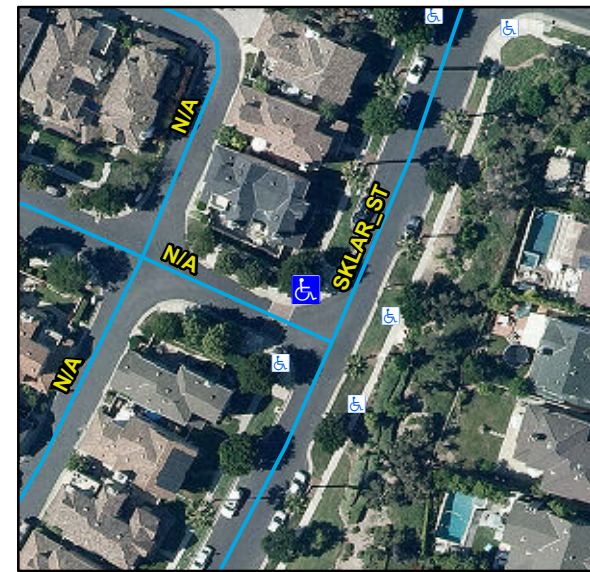
**R304.2.2, R204.3, R304.5.3, STD 1115**

| Compliance | Description | Data | Compliance | Description | Data |
|---|---|---|---|---|---|
| No | Ramp Cross Slope LT (%) | 2.5 | Yes | Ramp Cross Slope RT (%) | 1.2 |
| N/A | Gutter Ponding | N/A | No | Curb Slope | 11.1 |
| N/A | Gutter Cross Slope (%) | N/A | No | Perpendicular Joint Present | No |

**Remove & Replace Curb Ramp With Two New Directional Ramps or Equivalent.**

Total Cost: \$ 4000
