# Access Compliance Report Public Rights-of-Way (Curb Ramps)

Main Street: SKLAR\_ST Cross Street: N/A Location: W

ADA ID: RPRK211103124958 Ramp Type: Type 4 - Parallel Initial Pass/Fail: Pass Overall Compliance: No Severity Score: 25

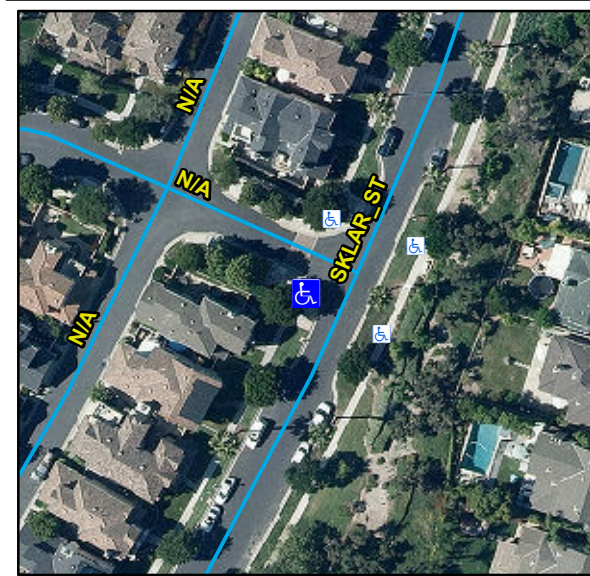
| Compliance | Description | Data | Compliance | Description | Data |
|---|---|---|---|---|---|
| N/A | Landing Present | No | No | DWS Provided | No |
| No | Landing Width (in) | N/A | N/A | DWS Length (in) | N/A |
| No | Landing Run Slope (%) | N/A | N/A | DWS Full Width | N/A |
| No | Landing Cross Slope (%) | N/A | | DWS Offset Type | N/A |
| No | Gutter Run Slope (%) | 5.7 | | Road Cross Slope (%) | 3.7 |
| Yes | Gutter Cross Slope (%) | 0.4 | No | Perpendicular Joint Present | No |

Possible Solutions:  
**Remove & Replace Curb Ramp With Two New Directional Ramps or Equivalent. Remove & Replace Gutter.**
