# Access Compliance Report Public Rights-of-Way (Curb Ramps)

Main Street: SKLAR\_ST Cross Street: HYDRANGEA\_ST Location: SE

ADA ID: RPRK211103130022 Ramp Type: Type 4 - Parallel Initial Pass/Fail: Fail Overall Compliance: No Severity Score: 16

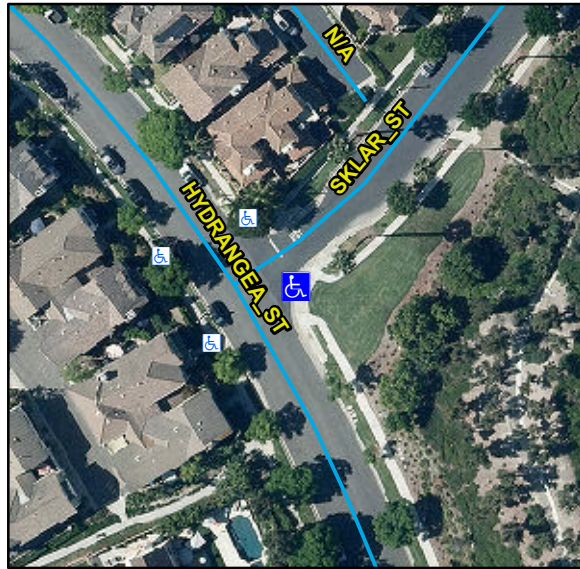
| Compliance | Description | Data | Compliance | Description | Data |
|---|---|---|---|---|---|
| Yes | Ramp Run Slope LT (%) | 3.2 | No | Ramp Run Slope RT (%) | 9 |
| No | Ramp Cross Slope LT (%) | 4.6 | Yes | Ramp Cross Slope RT (%) | 2 |

Remove & Replace Curb Ramp With Two New Directional Ramps or Equivalent.

R204.3, R304.5.3, R304.3.2, STD 1115

Total Cost: \$ 4000
