# Access Compliance Report Public Rights-of-Way (Curb Ramps)

| Main Street: HYDRANGEA_ST | | Cross Street: SKLAR_ST | | Location: | NE |
| ADA ID: RPRK211103130446 | Ramp Type: Type 4 - Parallel | Initial Pass/Fail: Fail | Overall Compliance: No | Severity Score: | 30 |

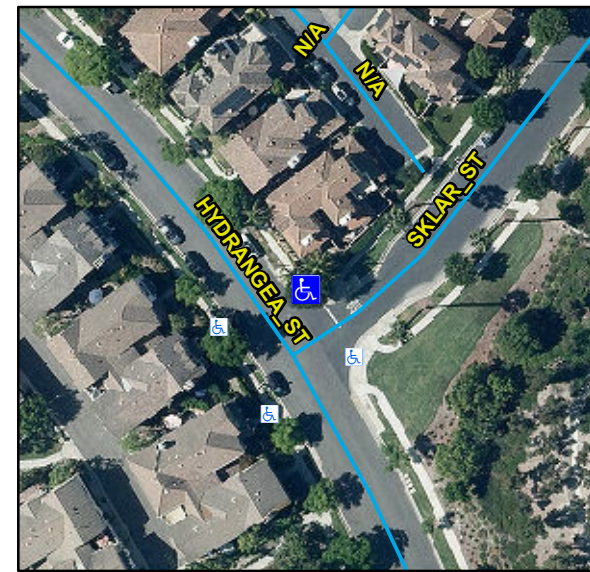
| Compliance | Description | Data | Compliance | Description | Data |
|---|---|---|---|---|---|
| No | Ramp Cross Slope LT (%) | 4.4 | No | Ramp Cross Slope RT (%) | 9 |

**Remove & Replace Curb Ramp With Two New Directional Ramps or Equivalent.**

**R204.3, R304.5.3, STD 1115**

Total Cost: \$ 4000

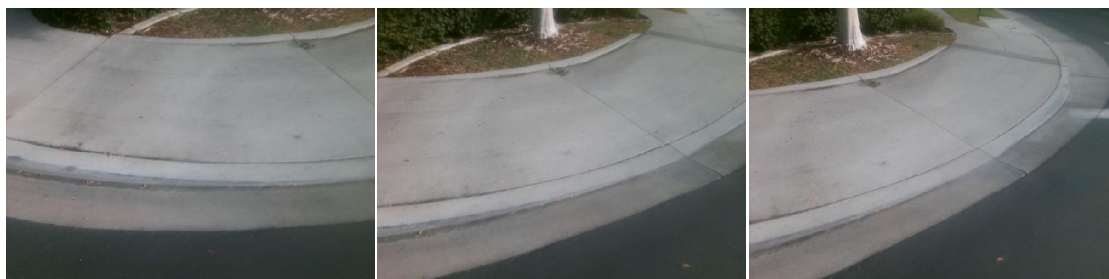
| Compliance | Description | Data | Compliance | Description | Data |
|---|---|---|---|---|---|
| N/A | Ramp Length LT (in) | 144 | N/A | Ramp Length RT (in) | 134 |
| Yes | Ramp Width LT (in) | 89 | Yes | Ramp Width RT (in) | 89 |
| Yes | Ramp Run Slope LT (%) | 2 | Yes | Ramp Run Slope RT (%) | 2 |
