# Access Compliance Report Public Rights-of-Way (Curb Ramps)

Main Street: S\_SELLAS\_RD Cross Street: TUBEROSE\_ST Location: SE

ADA ID: RPRK211103135813 Ramp Type: Type 4 - Parallel Initial Pass/Fail: Fail Overall Compliance: No Severity Score: 15

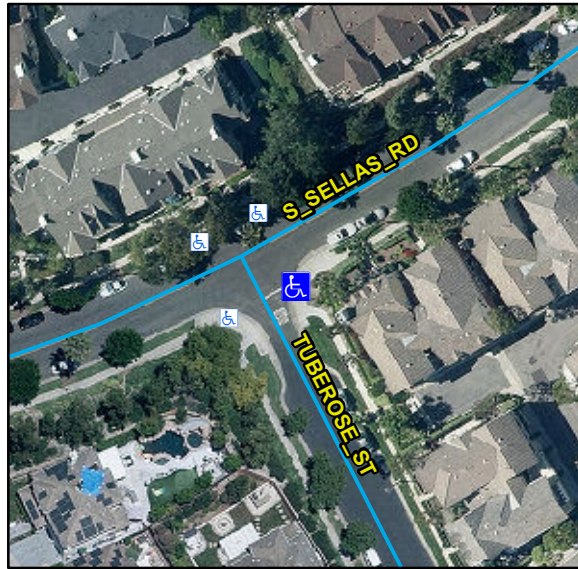
| Compliance | Description | Data | Compliance | Description | Data |
|---|---|---|---|---|---|
| No | Ramp Cross Slope LT (%) | 6.1 | No | Ramp Cross Slope RT (%) | 4.6 |
| N/A | Gutter Cross Slope (%) | N/A | No | Perpendicular Joint Present | No |

**Remove & Replace Curb Ramp With Two New Directional Ramps or Equivalent.**

**R204.3, R304.5.3, STD 1115**

Total Cost: \$ 4000
