# Access Compliance Report Public Rights-of-Way (Curb Ramps)

Main Street: TUBEROSE\_ST Cross Street: S\_SELLAS\_RD Location: SW

ADA ID: RPRK211103140229 Ramp Type: Type 4 - Parallel Initial Pass/Fail: Fail Overall Compliance: No Severity Score: 2

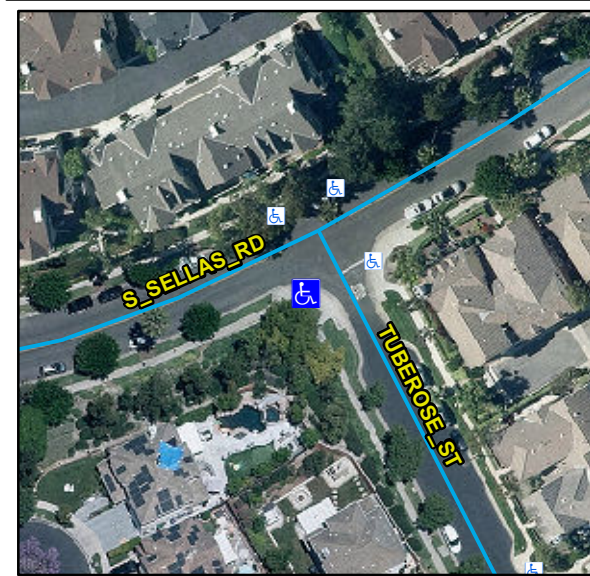
| Compliance | Description | Data | Compliance | Description | Data |
|---|---|---|---|---|---|
| N/A | Ramp Length LT (in) | 127 | N/A | Ramp Length RT (in) | 131 |
| Yes | Ramp Width LT (in) | 91 | Yes | Ramp Width RT (in) | 91 |
| Yes | Ramp Run Slope LT (%) | 7.7 | Yes | Ramp Run Slope RT (%) | 1.4 |
| No | Ramp Cross Slope LT (%) | 3.5 | No | Ramp Cross Slope RT (%) | 2.5 |

**Remove & Replace Curb Ramp With Two New Directional Ramps or Equivalent.**

**R204.3, R304.5.3, STD 1115**

Total Cost: \$ 4000
