# Access Compliance Report Public Rights-of-Way (Curb Ramps)

Main Street: S\_SELLAS\_RD Cross Street: WILDFLOWER Location: S

ADA ID: RPRK211103141349 Ramp Type: Type 4 - Parallel Initial Pass/Fail: Fail Overall Compliance: No Severity Score: 15

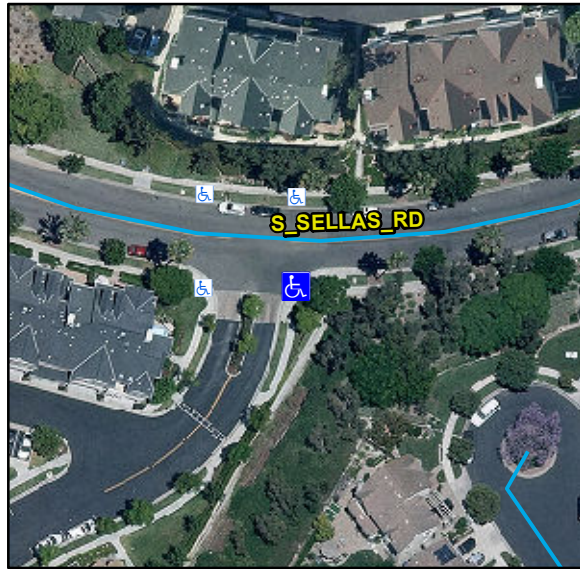
| Compliance | Description | Data | Compliance | Description | Data |
|---|---|---|---|---|---|
| No | Ramp Run Slope LT (%) | 8.6 | Yes | Ramp Run Slope RT (%) | 1.6 |

**Remove & Replace Curb Ramp With Two New Directional Ramps or Equivalent.**

**R204.3, R304.3.2, STD 1115**
