# Access Compliance Report Public Rights-of-Way (Curb Ramps)

Main Street: WILDFLOWER Cross Street: S\_SELLAS\_RD Location: SW

ADA ID: RPRK211103141830 Ramp Type: Type 4 - Parallel Initial Pass/Fail: Fail Overall Compliance: No Severity Score: 2

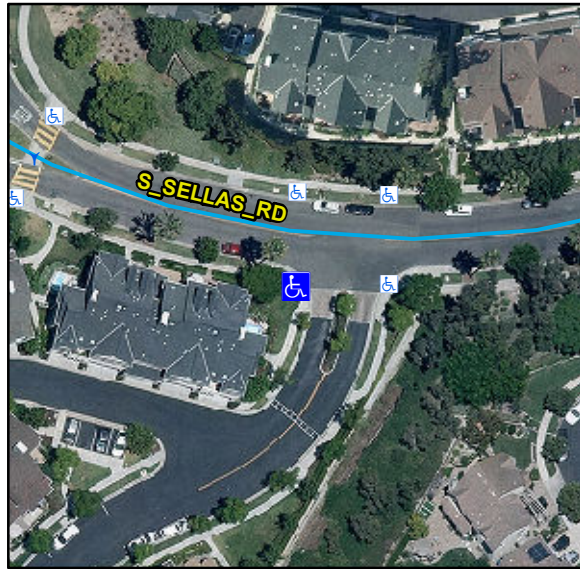
| Compliance | Description | Data | Compliance | Description | Data |
|---|---|---|---|---|---|
| Yes | Ramp Cross Slope LT (%) | 0.9 | No | Ramp Cross Slope RT (%) | 4.6 |

Remove & Replace Curb Ramp With Two New Directional Ramps or Equivalent.
