# Access Compliance Report Public Rights-of-Way (Curb Ramps)

| Main Street: TUBEROSE_ST | | Cross Street: ST MAYS | | Location: | NE |
| ADA ID: RPRK211103142733 | Ramp Type: Type 4 - Parallel | Initial Pass/Fail: Fail | Overall Compliance: No | Severity Score: | 2 |

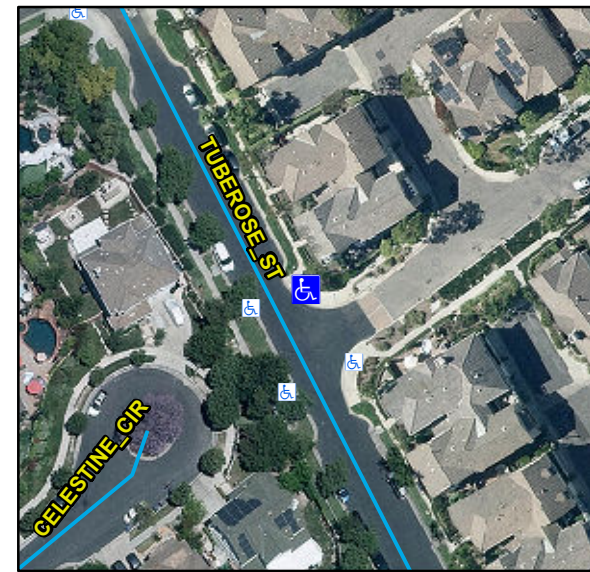
| Compliance | Description | Data | Compliance | Description | Data |
|---|---|---|---|---|---|
| Yes | Ramp Cross Slope LT (%) | 0.1 | No | Ramp Cross Slope RT (%) | 3.2 |

**Remove & Replace Curb Ramp With Two New Directional Ramps or Equivalent.**

**R204.3, R304.5.3, STD 1115**

Total Cost: \$ 4000
