# Access Compliance Report Public Rights-of-Way (Curb Ramps)

| Main Street: ST MAYS | | Cross Street: TUBEROSE_ST | | Location: | SE |
| ADA ID: RPRK211103143154 | Ramp Type: Type 4 - Parallel | Initial Pass/Fail: Fail | Overall Compliance: No | Severity Score: | 2 |

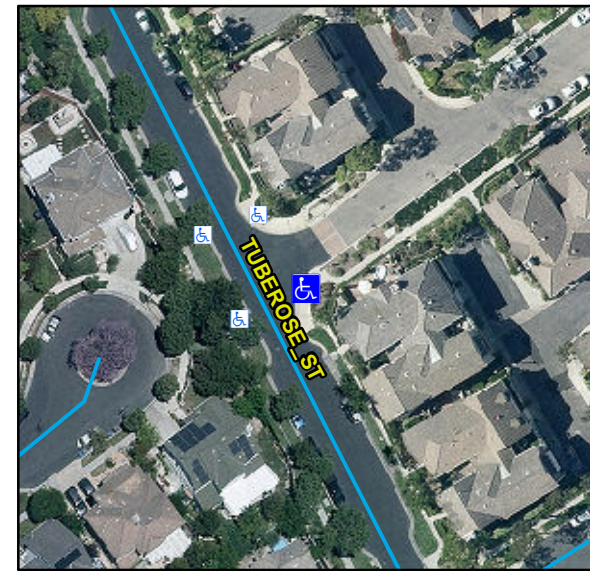
| Compliance | Description | Data | Compliance | Description | Data |
|---|---|---|---|---|---|
| No | Ramp Cross Slope LT (%) | 3.6 | No | Ramp Cross Slope RT (%) | 3.5 |

Possible Solutions:

**Remove & Replace Curb Ramp With Two New Directional Ramps or Equivalent.**

**R204.3, R304.5.3, STD 1115**

Total Cost: \$ 4000
