# Access Compliance Report Public Rights-of-Way (Curb Ramps)

Main Street: O\_NEILL\_DR Cross Street: NARROW\_CANYON\_RD Location: NW

ADA ID: RPRK211103151232 Ramp Type: Type 4 - Parallel Initial Pass/Fail: Fail Overall Compliance: No Severity Score: 2

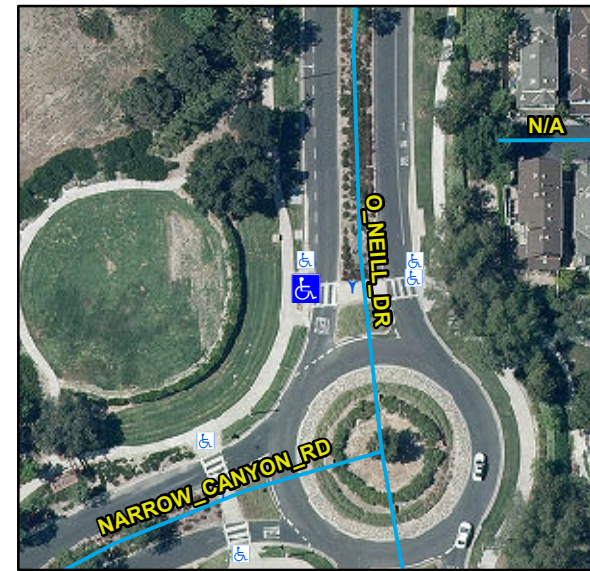
| Compliance | Description | Data | Compliance | Description | Data |
|---|---|---|---|---|---|
| No | Ramp Cross Slope LT (%) | 4.2 | N/A | Ramp Cross Slope RT (%) | -9999 |

Remove & Replace Entire Ramp.

R204.3, R304.5.3, STD 1115

Total Cost: \$ 2000
