# Access Compliance Report Public Rights-of-Way (Curb Ramps)

Main Street: O\_NEILL\_DR Cross Street: NARROW\_CANYON\_RD Location: NE

ADA ID: RPRK211103151621 Ramp Type: Type 4 - Parallel Initial Pass/Fail: Pass Overall Compliance: No Severity Score: 15

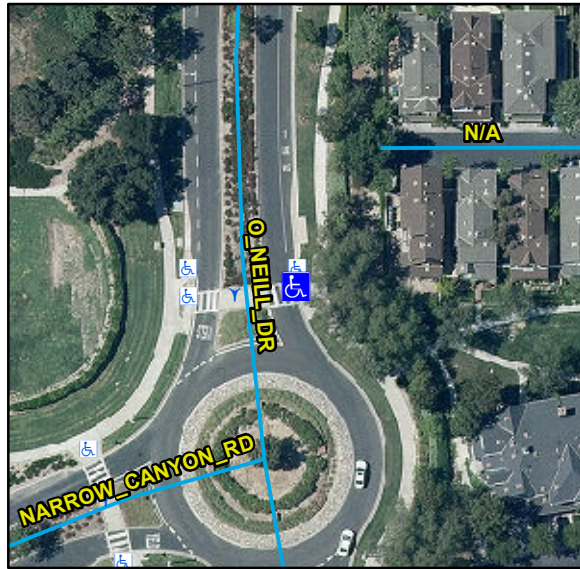
| Compliance | Description | Data | Compliance | Description | Data |
|---|---|---|---|---|---|
| N/A | Landing Present | Yes | No | DWS Provided | No |
| No | Gutter Run Slope (%) | 5.8 | | Road Cross Slope (%) | N/A |
| No | Gutter Cross Slope (%) | 2.7 | Yes | Perpendicular Joint Present | Yes |

Remove & Replace Entire Ramp. Remove & Replace Gutter.

R304.2.1, R305, R304.5.4, R304.5.3, STD 1115

Total Cost: \$ 2252
