# Access Compliance Report Public Rights-of-Way (Curb Ramps)

Main Street: O\_NEILL\_DR Cross Street: NARROW\_CANYON\_RD Location: SE

ADA ID: RPRK211103151746 Ramp Type: Type 4 - Parallel Initial Pass/Fail: Fail Overall Compliance: No Severity Score: 16

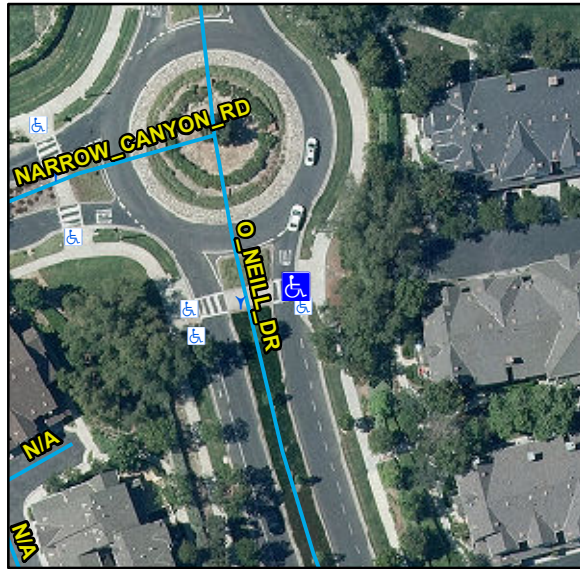
| Compliance | Description | Data | Compliance | Description | Data |
|---|---|---|---|---|---|
| No | Ramp Run Slope LT (%) | 8.9 | N/A | Ramp Run Slope RT (%) | -9999 |
| No | Ramp Cross Slope LT (%) | 2.9 | N/A | Ramp Cross Slope RT (%) | -9999 |

Remove & Replace Entire Ramp.

R204.3, R304.3.2, R304.5.3, STD 1115
