# Access Compliance Report Public Rights-of-Way (Curb Ramps)

Main Street: O\_NEILL\_DR Cross Street: ETON\_PL Location: N

ADA ID: RPRK211103153053 Ramp Type: Type 4 - Parallel Initial Pass/Fail: Fail Overall Compliance: No Severity Score: 2

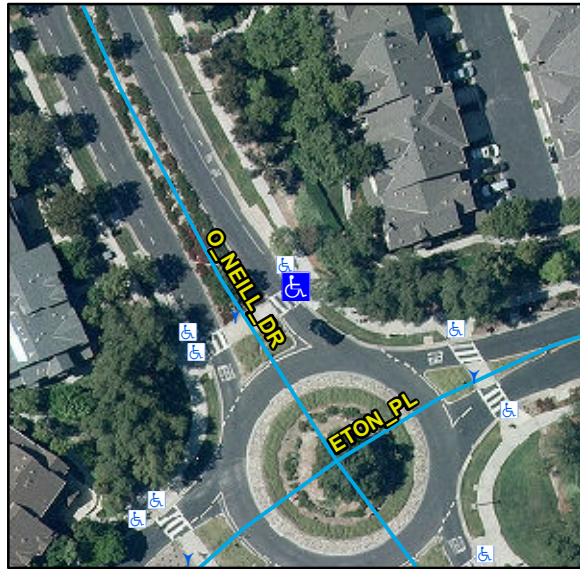
| Compliance | Description | Data | Compliance | Description | Data |
|---|---|---|---|---|---|
| N/A | Ramp Cross Slope LT (%) | -9999 | No | Ramp Cross Slope RT (%) | 2.1 |

**Remove & Replace Entire Ramp.**

**R304.5.3, STD 1115**
