# Access Compliance Report Public Rights-of-Way (Curb Ramps)

Main Street: O\_NEILL\_DR Cross Street: ETON\_PL Location: NW

ADA ID: RPRK211103153507 Ramp Type: Type 4 - Parallel Initial Pass/Fail: Fail Overall Compliance: No Severity Score: 2

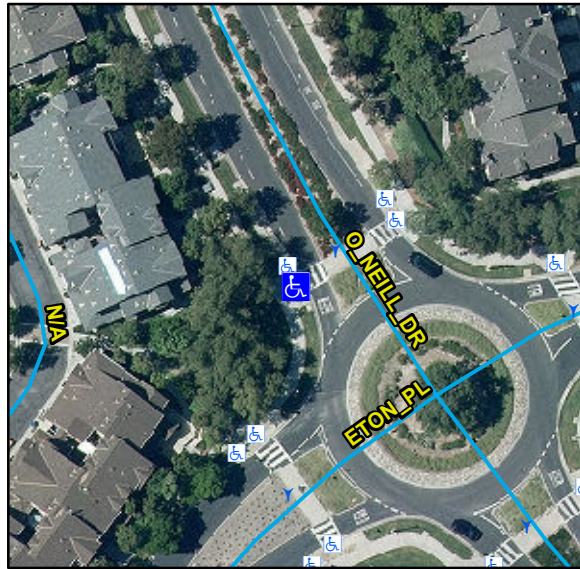
| Compliance | Description | Data | Compliance | Description | Data |
|---|---|---|---|---|---|
| N/A | Ramp Length LT (in) | 75 | N/A | Ramp Length RT (in) | -9999 |
| Yes | Ramp Width LT (in) | 48 | N/A | Ramp Width RT (in) | -9999 |
| Yes | Ramp Run Slope LT (%) | 8.1 | N/A | Ramp Run Slope RT (%) | -9999 |
| No | Ramp Cross Slope LT (%) | 2.5 | N/A | Ramp Cross Slope RT (%) | -9999 |

Possible Solutions:

Remove & Replace Entire Ramp.

R304.5.3, STD 1115

\$ 2000
