# Access Compliance Report Public Rights-of-Way (Curb Ramps)

Main Street: ETON\_PL Cross Street: O\_NEILL\_DR Location: W

ADA ID: RPRK211103153637 Ramp Type: Type 4 - Parallel Initial Pass/Fail: Fail Overall Compliance: No Severity Score: 16

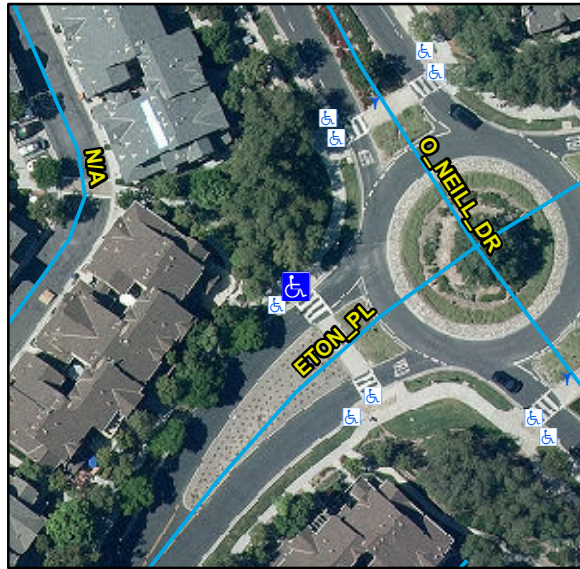
| Compliance | Description | Data | Compliance | Description | Data |
|---|---|---|---|---|---|
| N/A | Ramp Run Slope LT (%) | -9999 | No | Ramp Run Slope RT (%) | 8.4 |
| N/A | Ramp Cross Slope LT (%) | -9999 | No | Ramp Cross Slope RT (%) | 2.4 |

Remove & Replace Entire Ramp.

R304.3.2, R304.5.3, STD 1115
