# Access Compliance Report Public Rights-of-Way (Curb Ramps)

| Main Street: ETON_PL | | Cross Street: O_NEILL_DR | | Location: | W |
| ADA ID: RPRK211103154037 | Ramp Type: Type 4 - Parallel | Initial Pass/Fail: Fail | Overall Compliance: No | Severity Score: | 2 |

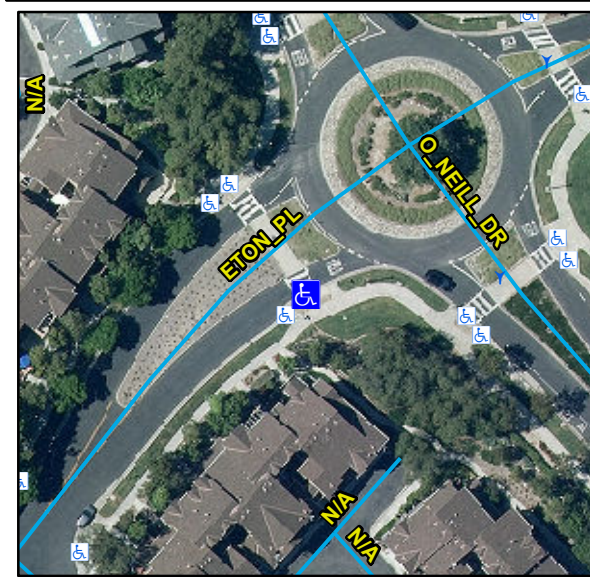
**N/A**

| Compliance | Description | Data | Compliance | Description | Data |
|---|---|---|---|---|---|
| No | Ramp Cross Slope LT (%) | 2.4 | N/A | Ramp Cross Slope RT (%) | -9999 |

**Remove & Replace Entire Ramp.**

**R304.5.3, STD 1115**

Total Cost: \$ 2000
