# Access Compliance Report Public Rights-of-Way (Curb Ramps)

Main Street: O\_NEILL\_DR Cross Street: ETON\_PL Location: S

ADA ID: RPRK211103154205 Ramp Type: Type 4 - Parallel Initial Pass/Fail: Fail Overall Compliance: No Severity Score: 2

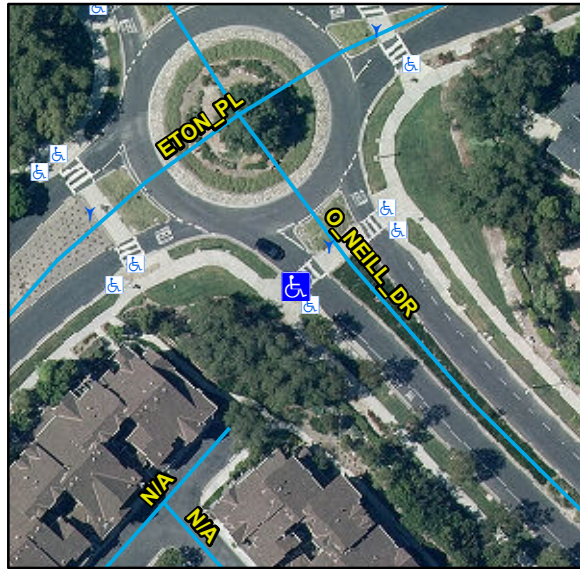
| Compliance | Description | Data | Compliance | Description | Data |
|---|---|---|---|---|---|
| N/A | Ramp Cross Slope LT (%) | -9999 | No | Ramp Cross Slope RT (%) | 4.2 |
| N/A | Gutter Ponding | N/A | No | Curb Slope | 9.4 |

Remove & Replace Entire Ramp.

R304.2.2, R304.5.3, STD 1115
