# Access Compliance Report Public Rights-of-Way (Curb Ramps)

| Main Street: O_NEILL_DR | | Cross Street: ETON_PL | | Location: | S |
| ADA ID: RPRK211103154618 | Ramp Type: Type 4 - Parallel | Initial Pass/Fail: Fail | Overall Compliance: No | Severity Score: | 15 |

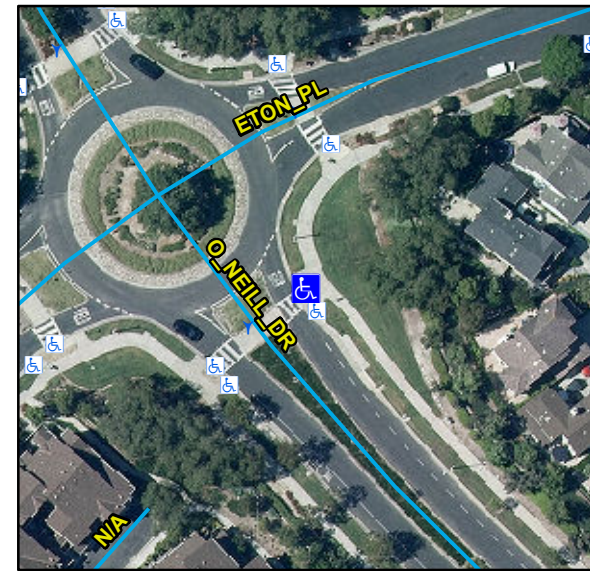
**R304.3.2, STD 1115**

| Compliance | Description | Data | Compliance | Description | Data |
|---|---|---|---|---|---|
| No | Ramp Run Slope LT (%) | 10.5 | N/A | Ramp Run Slope RT (%) | -9999 |

**Remove & Replace Entire Ramp.**

Total Cost: \$ 2000

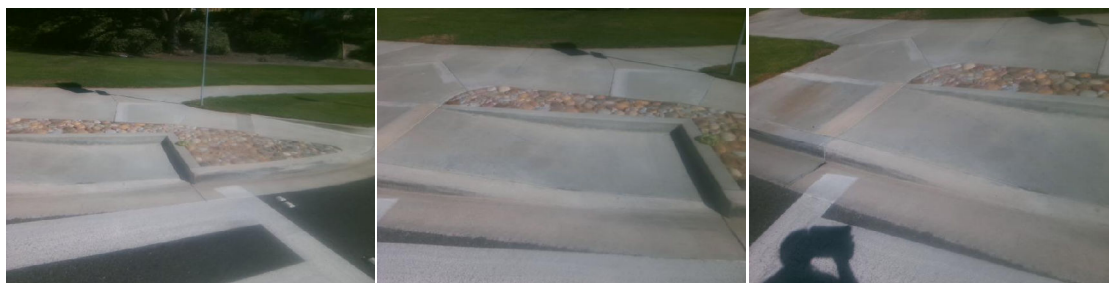
| Compliance | Description | Data | Compliance | Description | Data |
|---|---|---|---|---|---|
| N/A | Ramp Length LT (in) | 72 | N/A | Ramp Length RT (in) | -9999 |
| Yes | Ramp Width LT (in) | 48 | N/A | Ramp Width RT (in) | -9999 |
| Yes | Ramp Cross Slope LT (%) | 1.1 | N/A | Ramp Cross Slope RT (%) | -9999 |
