# Access Compliance Report Public Rights-of-Way (Curb Ramps)

| Main Street: EPONA_WAY | | Cross Street: EPONA_WAY | | Location: | W |
| ADA ID: RPRK211103155422 | Ramp Type:Type 1 - Perpendicular | Initial Pass/Fail: Pass | Overall Compliance: No | Severity Score: | 15 |

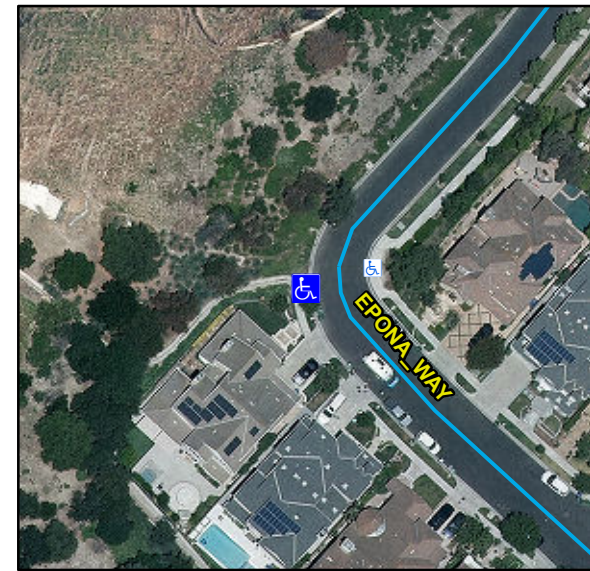
**R304.2.2, R304.2.1, R305, R304.5.4, STD 1115**

| Compliance | Description | Data | Compliance | Description | Data |
|---|---|---|---|---|---|
| Yes | Landing Cross Slope (%) | 0.4 | No | DWS Provided | No |
| Yes | Gutter Ponding | No | No | Curb Slope | 15.7 |
| No | Gutter Run Slope (%) | 7.1 | | Road Cross Slope (%) | N/A |

**Remove & Replace Entire Ramp. Remove & Replace Gutter.**

Total Cost: \$ 3332

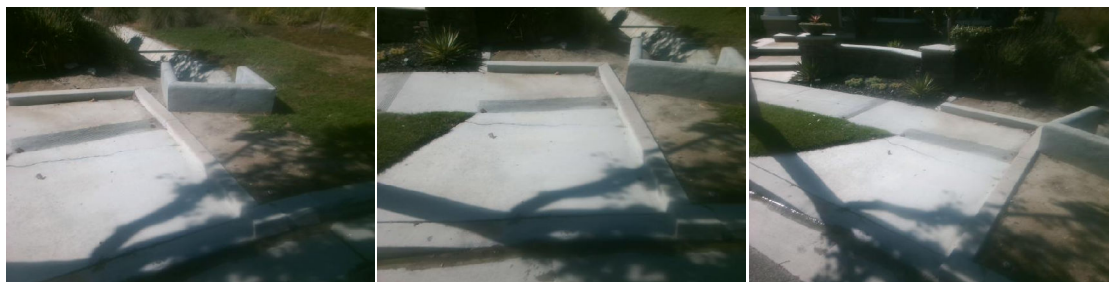
| Compliance | Description | Data | Compliance | Description | Data |
| N/A | Ramp Length (in) | 55 | N/A | Flare Type LT | |
| Yes | Ramp Width (in) | 52 | | | Sloped |
| Yes | Ramp Run Slope (%) | 7.9 | N/A | Flare Slope LT (%) | 10.5 |

Possible Solutions:
