# Access Compliance Report Public Rights-of-Way (Curb Ramps)

Main Street: **NARROW\_CANYON\_RD** Cross Street: **N/A** Location: **N**

ADA ID: **RPRK211103161015** Ramp Type: **Type 4 - Parallel** Initial Pass/Fail: **Pass** Overall Compliance: **No** Severity Score: **25**

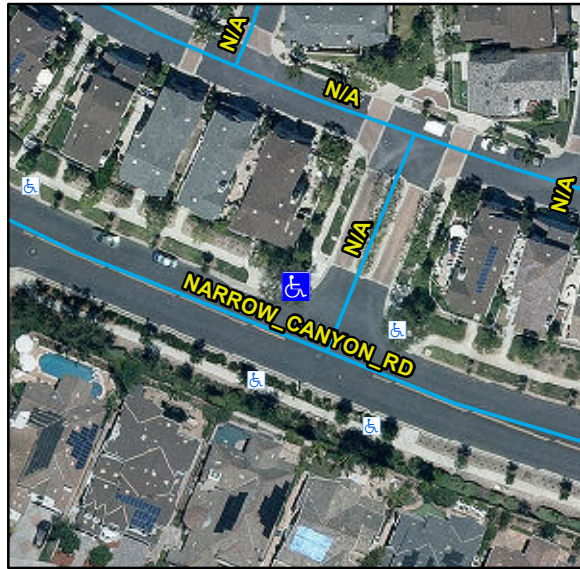
| Compliance | Description | Data | Compliance | Description | Data |
|---|---|---|---|---|---|
| <b>N/A</b> | Landing Present | <b>No</b> | <b>No</b> | DWS Provided | <b>No</b> |
| <b>No</b> | Landing Width (in) | <b>N/A</b> | <b>N/A</b> | DWS Length (in) | <b>N/A</b> |
| <b>No</b> | Landing Run Slope (%) | <b>N/A</b> | <b>N/A</b> | DWS Full Width | <b>N/A</b> |
| <b>No</b> | Landing Cross Slope (%) | <b>N/A</b> | | DWS Offset Type | <b>N/A</b> |
| <b>Yes</b> | Gutter Ponding | <b>No</b> | <b>No</b> | Curb Slope | <b>12.3</b> |
| <b>No</b> | Gutter Run Slope (%) | <b>7.5</b> | | Road Cross Slope (%) | <b>3.5</b> |

**Remove & Replace Curb Ramp With Two New Directional Ramps or Equivalent. Remove & Replace Gutter.**
