# Access Compliance Report Public Rights-of-Way (Curb Ramps)

Main Street: N/A Cross Street: NARROW\_CANYON\_RD Location: E

ADA ID: RPRK211103161232 Ramp Type: Type 4 - Parallel Initial Pass/Fail: Pass Overall Compliance: No Severity Score: 25

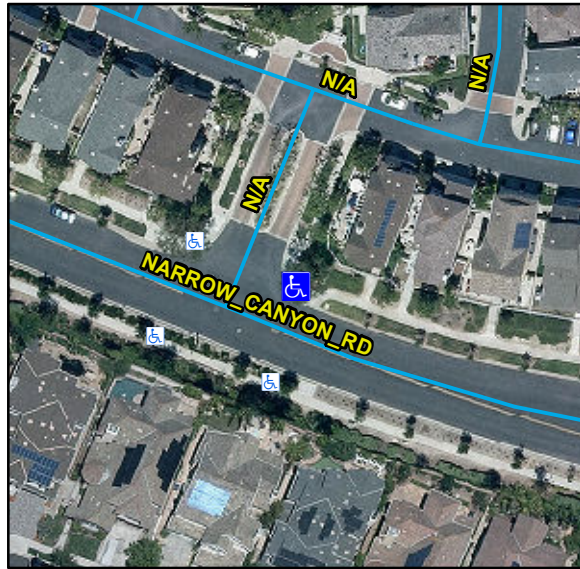
| Compliance | Description | Data | Compliance | Description | Data |
|---|---|---|---|---|---|
| N/A | Landing Present | No | No | DWS Provided | No |
| No | Landing Width (in) | N/A | N/A | DWS Length (in) | N/A |
| No | Landing Run Slope (%) | N/A | N/A | DWS Full Width | N/A |
| No | Landing Cross Slope (%) | N/A | | DWS Offset Type | N/A |
| Yes | Gutter Ponding | No | Yes | Curb Slope | 6 |
| No | Gutter Lip Height (in) | 0.25 | | Road Run Slope (%) | 1.4 |
| No | Gutter Run Slope (%) | 8.1 | | Road Cross Slope (%) | 2.9 |
| No | Gutter Cross Slope (%) | 3.1 | No | Perpendicular Joint Present | No |

Remove & Replace Curb Ramp With Two New Directional Ramps or Equivalent. Remove & Replace Gutter.
