# Access Compliance Report Public Rights-of-Way (Curb Ramps)

Main Street: ETHEREAL\_ST Cross Street: CITRUS\_LN Location: S

ADA ID: RPRK211103161526 Ramp Type: Type 4 - Parallel Initial Pass/Fail: Pass Overall Compliance: No Severity Score: 10

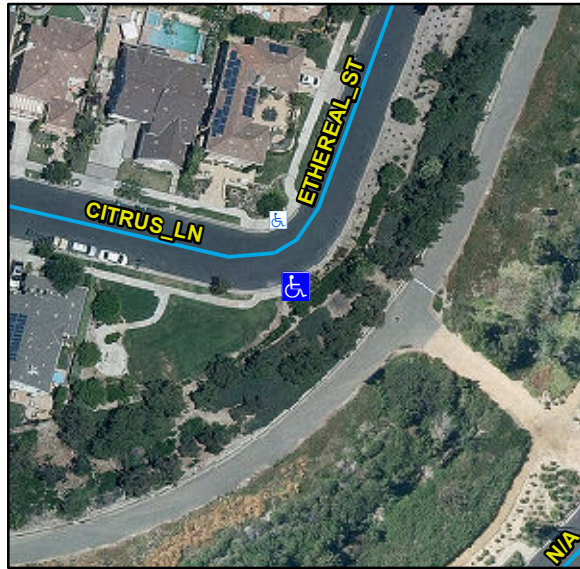
| Compliance | Description | Data | Compliance | Description | Data |
|---|---|---|---|---|---|
| N/A | Landing Present | Yes | No | DWS Provided | No |
| Yes | Gutter Cross Slope (%) | 0.4 | No | Perpendicular Joint Present | No |

Remove & Replace Entire Ramp.

R204.3, R304.2.1, R305, STD 1115

Total Cost: \$ 2000
