# Access Compliance Report Public Rights-of-Way (Curb Ramps)

Main Street: **NARROW\_CANYON\_RD** Cross Street: **NARROW\_CANYON\_RD** Location: **N**

ADA ID: **RPRK211103162852** Ramp Type: **Type 1 - Perpendicular** Initial Pass/Fail: **Fail** Overall Compliance: **No** Severity Score: **16**

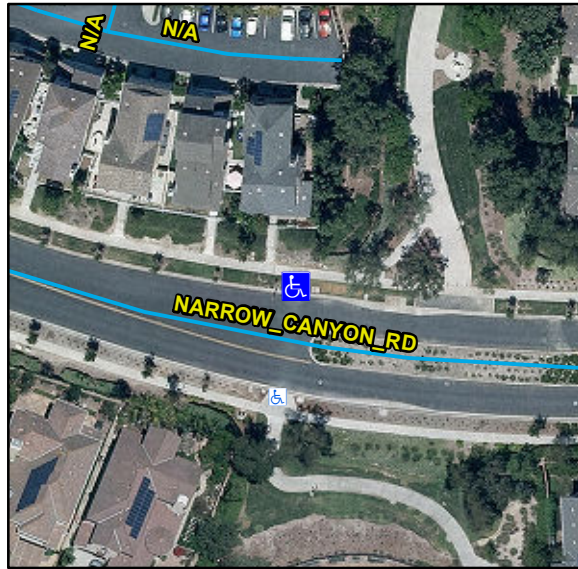
| Compliance | Description | Data | Compliance | Description | Data |
|---|---|---|---|---|---|
| <b>No</b> | Ramp Run Slope (%) | <b>10</b> | <b>N/A</b> | Flare Slope LT (%) | <b>N/A</b> |
| <b>N/A</b> | Gutter Ponding | <b>N/A</b> | <b>No</b> | Curb Slope | <b>11.5</b> |

**Remove & Replace Entire Ramp.**
