# Access Compliance Report Public Rights-of-Way (Curb Ramps)

Main Street: **NARROW\_CANYON\_RD** Cross Street: **NARROW\_CANYON\_RD** Location: **S**

ADA ID: **RPRK211103163132** Ramp Type: **Type 1 - Perpendicular** Initial Pass/Fail: **Pass** Overall Compliance: **No** Severity Score: **26**

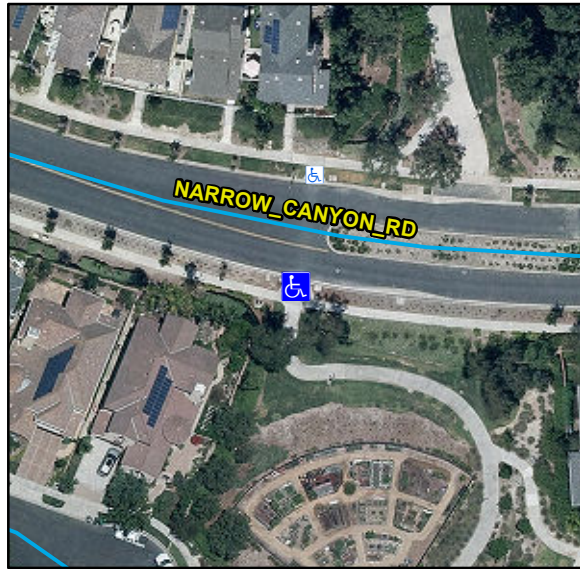
| Compliance | Description | Data | Compliance | Description | Data |
|---|---|---|---|---|---|
| Yes | Landing Cross Slope (%) | 0.6 | No | DWS Provided | No |
| No | Gutter Lip Height (in) | 1 | | Road Run Slope (%) | N/A |
| No | Gutter Run Slope (%) | 12.8 | | Road Cross Slope (%) | N/A |

**Remove & Replace Entire Ramp. Remove & Replace Gutter.**

**R304.2.2, R305, R302.7.2, R304.5.4, STD 1115**
