# Access Compliance Report Public Rights-of-Way (Curb Ramps)

Main Street: N/A Cross Street: ETHEREAL\_RD Location: NW

ADA ID: RPRK211103163948 Ramp Type: Type 4 - Parallel Initial Pass/Fail: Fail Overall Compliance: No Severity Score: 32

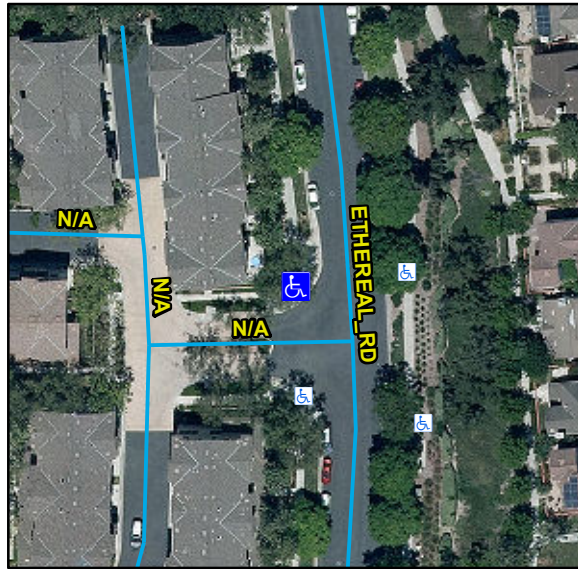
| Compliance | Description | Data | Compliance | Description | Data |
|---|---|---|---|---|---|
| Yes | Ramp Run Slope LT (%) | 4.7 | No | Ramp Run Slope RT (%) | 16.8 |
| No | Ramp Cross Slope LT (%) | 2.1 | Yes | Ramp Cross Slope RT (%) | 1.6 |

Remove & Replace Curb Ramp With Two New Directional Ramps or Equivalent.

R204.3, R304.5.3, R304.3.2, STD 1115

Total Cost: \$ 4000
