# Access Compliance Report Public Rights-of-Way (Curb Ramps)

| Main Street: ETHEREAL_RD | | Cross Street: N/A | | Location: | SW |
| ADA ID: RPRK211103164141 | Ramp Type: Type 4 - Parallel | Initial Pass/Fail: Fail | Overall Compliance: No | Severity Score: | 2 |

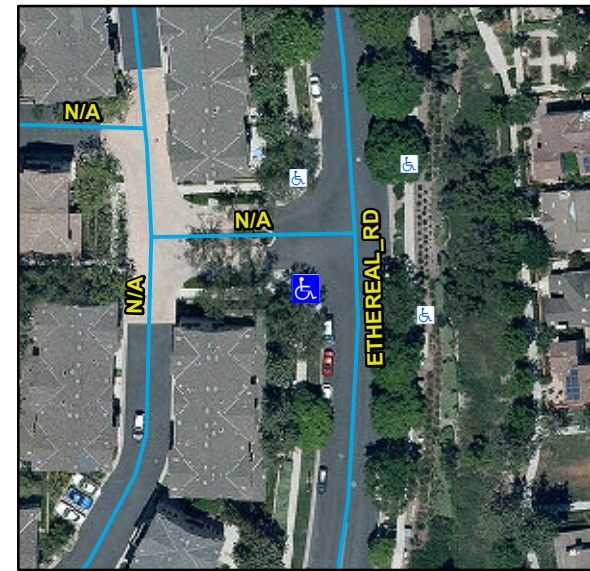
| Compliance | Description | Data | Compliance | Description | Data |
|---|---|---|---|---|---|
| Yes | Ramp Cross Slope LT (%) | 1.3 | No | Ramp Cross Slope RT (%) | 2.6 |

**Remove & Replace Curb Ramp With Two New Directional Ramps or Equivalent.**

**R304.5.3, STD 1115**

Total Cost: \$ 4000
