# Access Compliance Report Public Rights-of-Way (Curb Ramps)

Main Street: ETHEREAL\_RD Cross Street: SIENNA\_PKWY Location: N

ADA ID: RPRK211104121536 Ramp Type: Type 1 - Perpendicular Initial Pass/Fail: Fail Overall Compliance: No Severity Score: 15

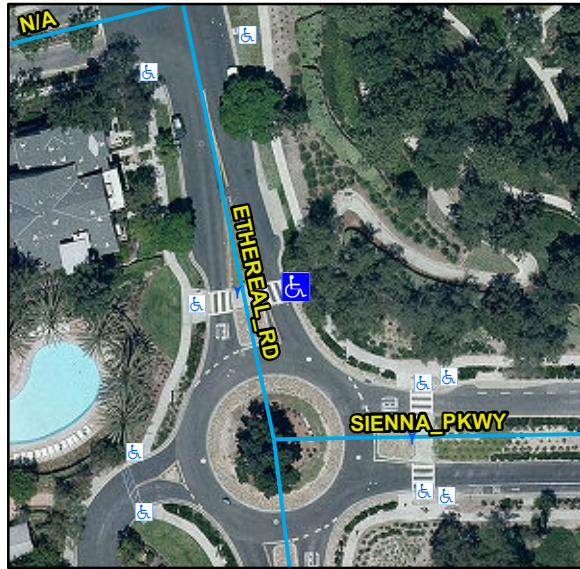
| Compliance | Description | Data | Compliance | Description | Data |
|---|---|---|---|---|---|
| No | Ramp Run Slope (%) | 10.9 | N/A | Flare Slope LT (%) | N/A |
| N/A | Gutter Ponding | N/A | No | Curb Slope | 12.7 |

Remove & Replace Entire Ramp.

R304.2.2, R204.3, STD 1115
