# Access Compliance Report Public Rights-of-Way (Curb Ramps)

Main Street: SIENNA\_PKWY Cross Street: ETHEREAL\_RD Location: E

ADA ID: RPRK211104121828 Ramp Type: Type 1 - Perpendicular Initial Pass/Fail: Fail Overall Compliance: No Severity Score: 4

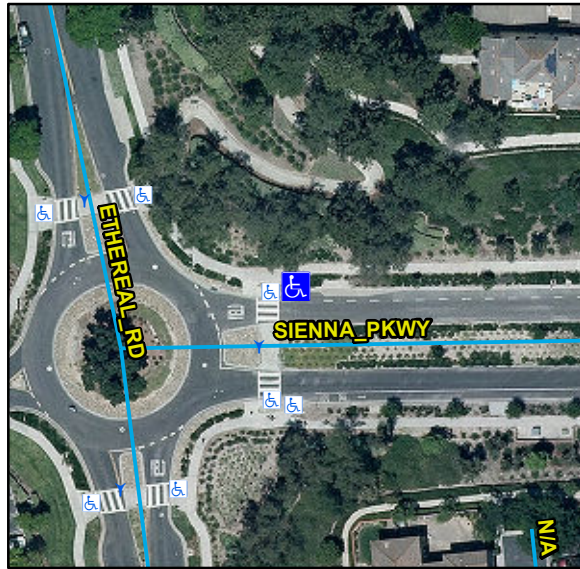
| Compliance | Description | Data | Compliance | Description | Data |
|---|---|---|---|---|---|
| No | Ramp Width (in) | 46 | | | N/A |

Remove & Replace Entire Ramp.
