# Access Compliance Report Public Rights-of-Way (Curb Ramps)

Main Street: SIENNA\_PKWY Cross Street: ETHEREAL\_RD Location: E

ADA ID: RPRK211104122412 Ramp Type: Type 1 - Perpendicular Initial Pass/Fail: Fail Overall Compliance: No Severity Score: 2

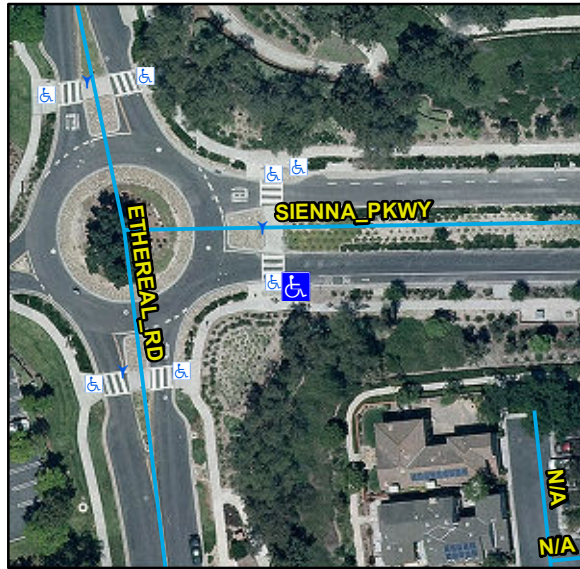
| Compliance | Description | Data | Compliance | Description | Data |
|---|---|---|---|---|---|
| No | Ramp Cross Slope (%) | 2.1 | N/A | Flare Traversable LT | N/A |
| N/A | Gutter Ponding | N/A | No | Curb Slope | 11.8 |

Remove & Replace Entire Ramp.

R304.2.2, R204.3, R304.5.3, STD 1115

Total Cost: \$ 3080
