# Access Compliance Report Public Rights-of-Way (Curb Ramps)

Main Street: ETHEREAL\_RD Cross Street: SIENNA\_PKWY Location: S

ADA ID: RPRK211104122520 Ramp Type: Type 1 - Perpendicular Initial Pass/Fail: Fail Overall Compliance: No Severity Score: 2

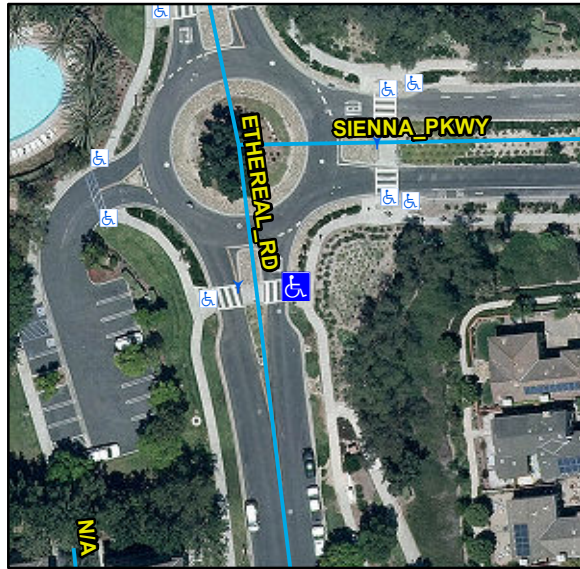
| Compliance | Description | Data | Compliance | Description | Data |
|---|---|---|---|---|---|
| No | Ramp Cross Slope (%) | 2.6 | N/A | Flare Traversable LT | N/A |
| N/A | Gutter Ponding | N/A | No | Curb Slope | 15.1 |

Remove & Replace Entire Ramp.
