# Access Compliance Report Public Rights-of-Way (Curb Ramps)

Main Street: ETHEREAL\_RD Cross Street: SIENNA\_PKWY Location: S

ADA ID: RPRK211104122831 Ramp Type: Type 1 - Perpendicular Initial Pass/Fail: Fail Overall Compliance: No Severity Score: 16

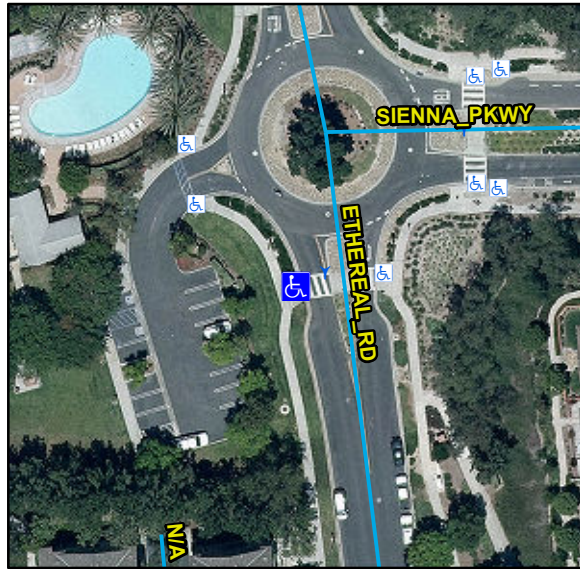
| Compliance | Description | Data | Compliance | Description | Data |
|---|---|---|---|---|---|
| No | Ramp Run Slope (%) | 8.4 | N/A | Flare Slope LT (%) | N/A |
| N/A | Gutter Ponding | N/A | No | Curb Slope | 12.8 |

Remove & Replace Entire Ramp.

R304.2.2, R204.3, STD 1115
