Access Compliance Report Public Rights-of-Way (Curb Ramps)

Main Street: **N/A** Cross Street: **ETHEREAL_RD** Location: **W**

ADA ID: **RPRK211104122932** Ramp Type: **Type 4 - Parallel** Initial Pass/Fail: **Fail** Overall Compliance: **No** Severity Score: **19**

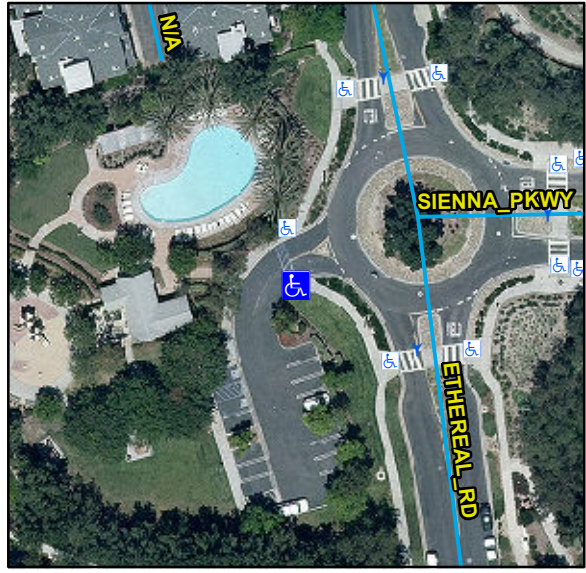
Compliance	Description	Data	Compliance	Description	Data
N/A	Ramp Length LT (in)	110	N/A	Ramp Length RT (in)	-9999
No	Ramp Width LT (in)	45	N/A	Ramp Width RT (in)	-9999
No	Ramp Run Slope LT (%)	10.1	N/A	Ramp Run Slope RT (%)	-9999
Yes	Ramp Cross Slope LT (%)	1.2	N/A	Ramp Cross Slope RT (%)	-9999
N/A	Landing Present	N/A	N/A	DWS Provided	N/A
N/A	Landing Length (in)	N/A	N/A	DWS Contrast	N/A
N/A	Landing Width (in)	N/A	N/A	DWS Length (in)	N/A
N/A	Landing Run Slope (%)	N/A	N/A	DWS Full Width	N/A
N/A	Landing Cross Slope (%)	N/A		DWS Offset Type	N/A
N/A	Landing Movement Obstructed?	N/A	N/A	DWS Offset Left (in)	N/A
	Landing Movement Type	N/A	N/A	DWS Offset Right (in)	N/A
N/A	Landing Shared	N/A			
N/A	Clear Space	N/A			
N/A	Clear Space To Crosswalk (in)	N/A			
N/A	Marked Crosswalk 1	Yes	N/A	Marked Crosswalk 2	N/A
	Crossing 1 Direction	N		Crossing 2 Direction	N/A
N/A	Marked Crosswalk 1 Width (in)	56		Marked Crosswalk 2 Width (in)	N/A

N/A	Ramp Inside Crosswalk 1	Yes	N/A	Ramp Inside Crosswalk 2	N/A
	Crossing 1 Slope (%)	2.9		Crossing 2 Slope (%)	N/A
	Crossing 1 Cross Slope (%)	4.7		Crossing 2 Cross Slope (%)	N/A
N/A	Gutter Ponding	N/A	N/A	Curb Slope	8.9
Yes	Gutter Lip Height (in)	0		Road Run Slope (%)	N/A
N/A	Gutter Run Slope (%)	N/A		Road Cross Slope (%)	N/A
N/A	Gutter Cross Slope (%)	N/A	No	Perpendicular Joint Present	No
Yes	Overall Surface Condition	Acceptable		Spandrel Present?	No
	Cross Gutter Present?	No		Replace Spandrel?	N/A
	Replace Cross Gutter?	N/A

Possible Solutions:
Remove & Replace Entire Ramp.

OC Std/PROW:
R204.3, R304.5.1, R304.3.2, STD 1115

Total Cost: **\$ 2000**
